**RICHARD L. MEEHAN**

Re: Dairi Prima Minerals (DPM) Mine site risks and Tailings disposal safety. Review of Dairi April 2021 EIA Addendum.

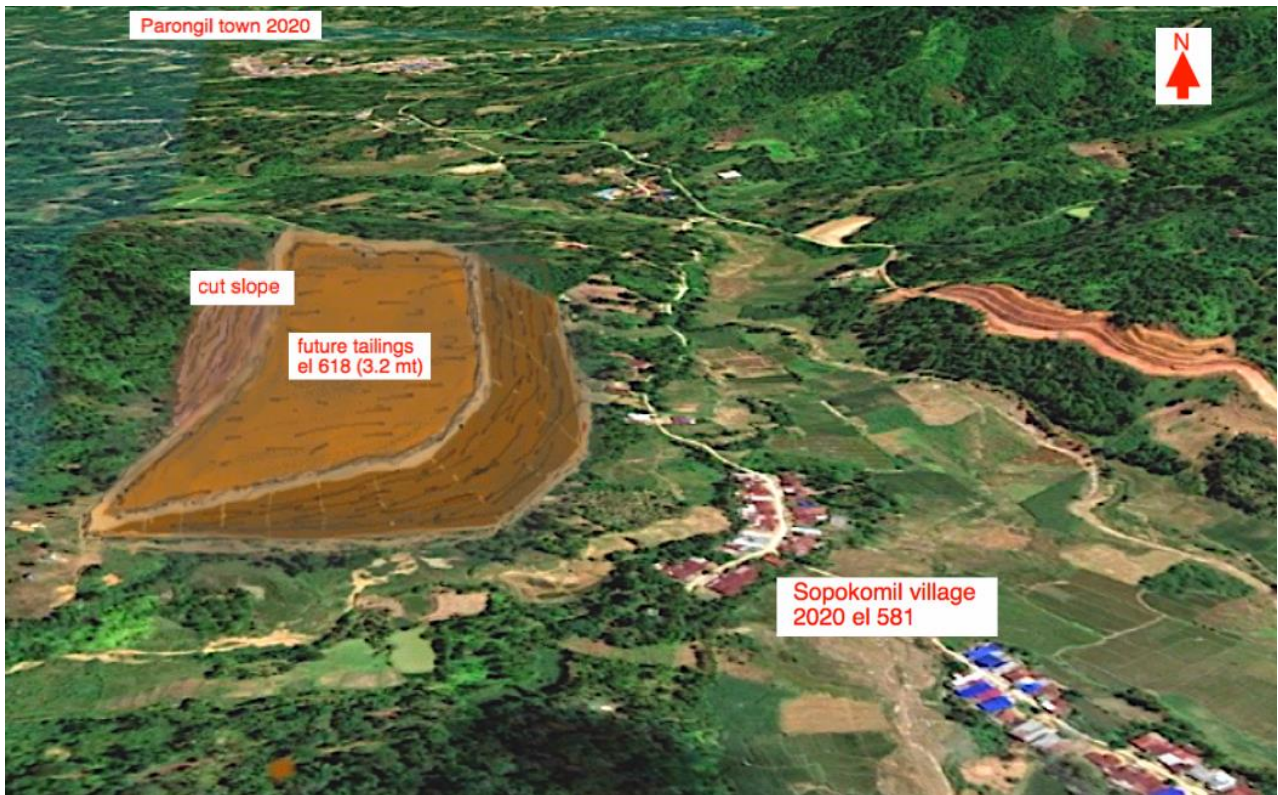
*Figure 1. Planned configuration of TSF, 3.2 million tons at elevation 618. TSF configuration (brown color) from EIA Addendum fig 2.22 sketched onto Google Earth image by the author. Breach of the tailings dam above the Sopokomil village is likely in a strong earthquake because the ground between and beneath the village and the TSF and the dam foundation is unstable volcanic ash soils subject to liquefaction and landsliding.*

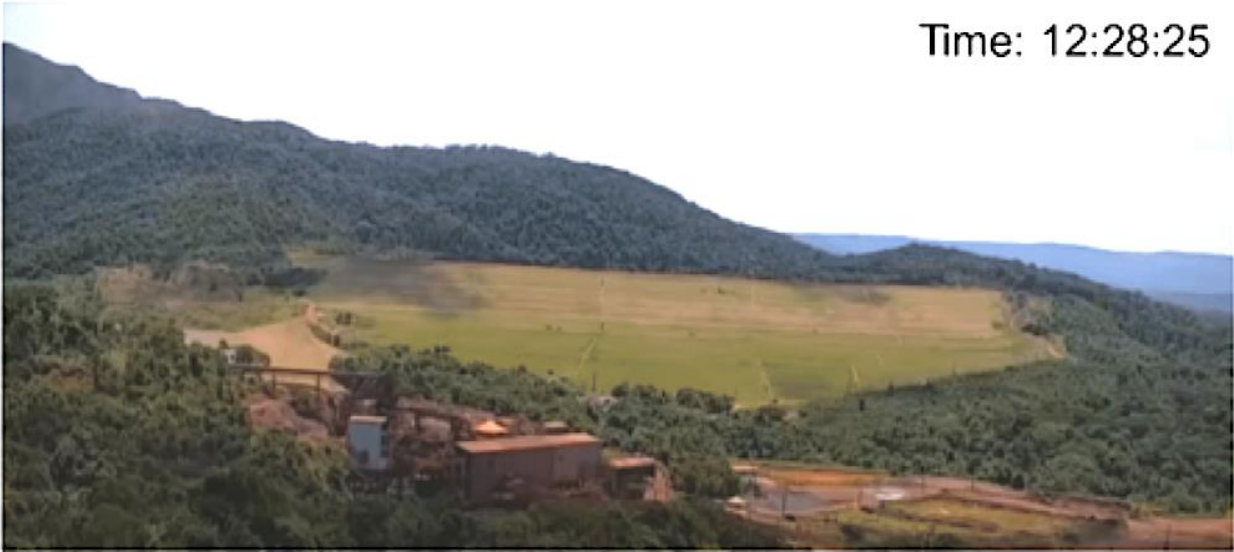
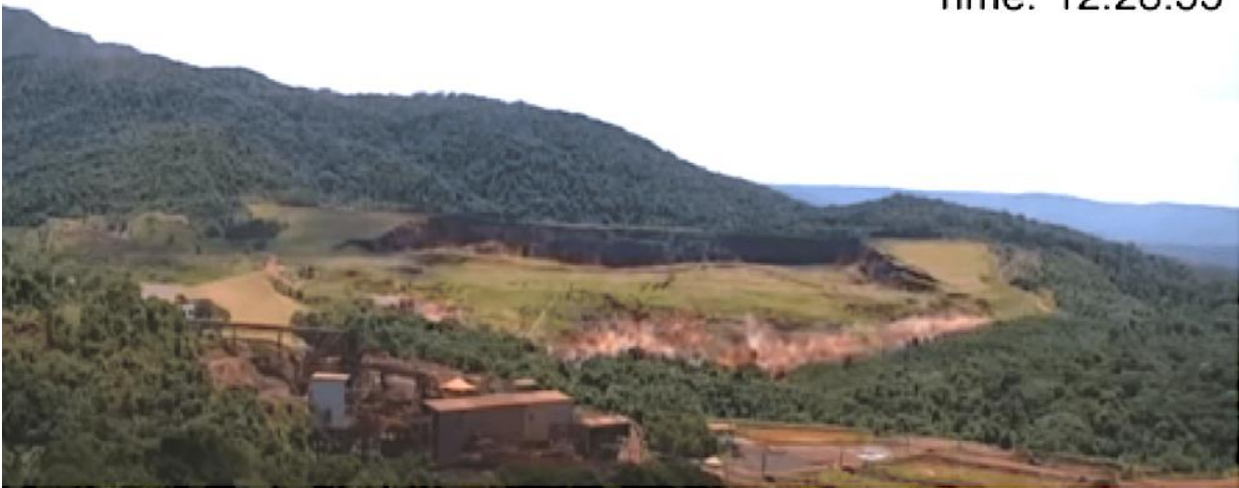
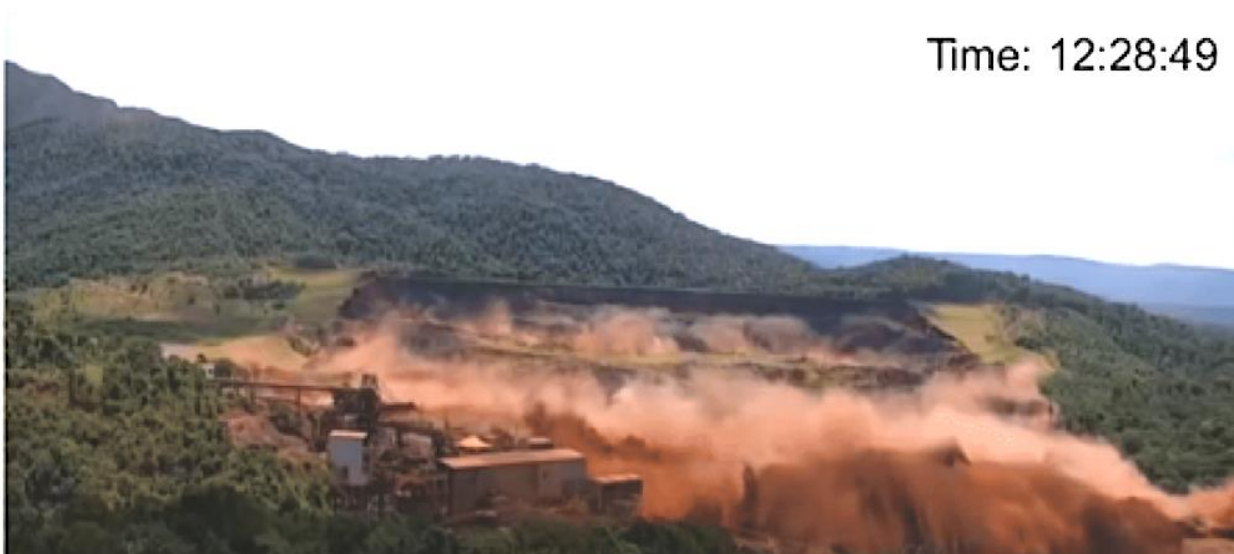
The best known tailings failure of our times is the Brumindinho failure in Brazil in 2018. This has been discussed in my previous reports. The photos shown here are during the course of the failure and show the entire containment “wall” of the tailings failing simultaneously. The containment, or a dam wall, in this case was of the dangerous design that was used traditionally in TSF facilities but has a record of high frequency of failure. It consisted of no more than a thin shell of small dikes holding back a large lake of easily liquefied tailings. Failure has occurred with these designs either spontaneously or after even a moderate wet season.

*Figure 2 Brumindinho TSF failure 2018*

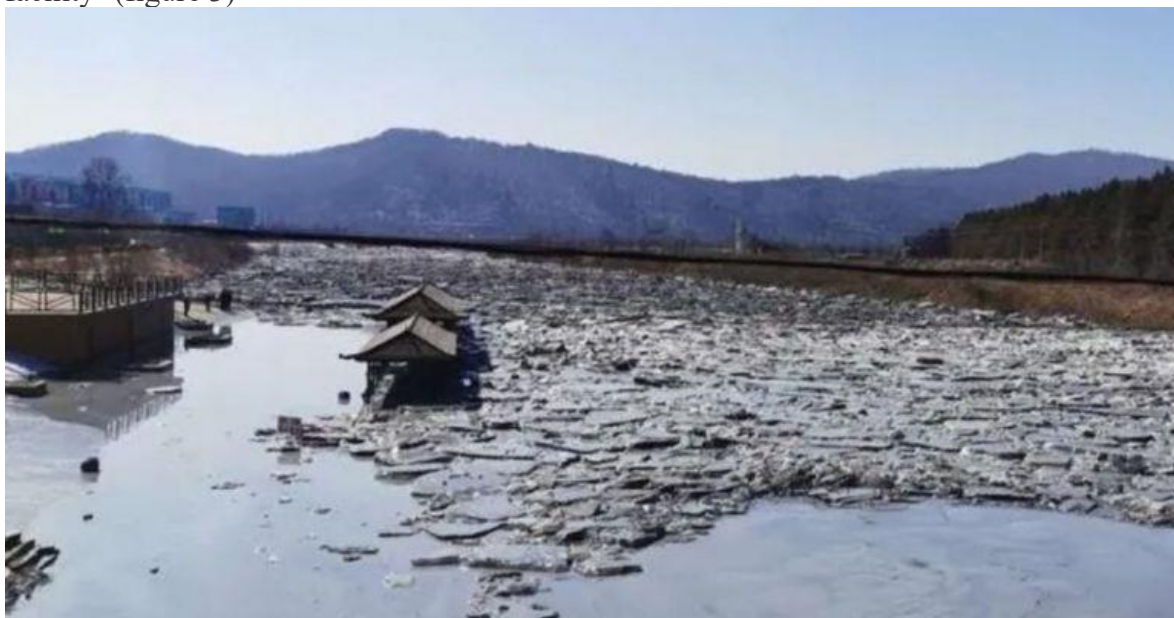
(2) failure of elements of temporary or permanent underground drainage such as occurred at the Chinese molybdenum tailings dam last year and sent toxic materials some 123 km downstream of the facility<sup>6</sup> (figure 3)

*Figure 3 An unstable foundation may also lead to a TSF spill that would not necessarily destroy villages, but rather flood downstream streams with toxic waste as here last year at China's Yichun Luming TSF.*

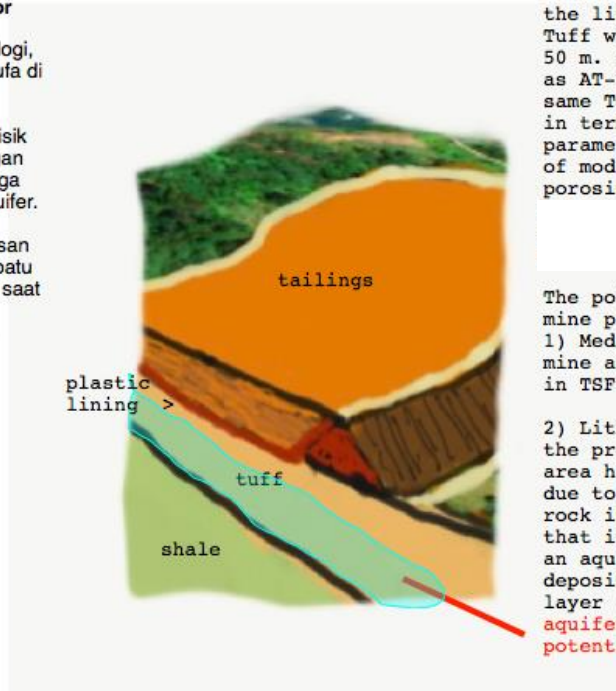
In the TSF infrastructure plan area, the lithology is dominated by Toba Tuff which has a thickness of up to 50 m. Several monitoring wells, such as AT-6 and AT-10, were formed in the same Toba Tuff rock unit. Toba Tuff in terms of hydrogeological parameters is included in the level of moderate to high water porosity.

The potential for landslides in the mine plan area is caused by:  
 1) Medium to high rainfall in the mine area ranges from 1,500 mm / year in TSF area.

2) Lithology: geological conditions, the presence of tuff rock in the TSF area has the potential for landslides due to the physical properties of the rock itself with high porosity so that it has the potential to become an aquifer. The tuff rock is deposited in the impermeable rock layer (shale) so that when the aquifer becomes saturated it has the potential for landslides.

Figure 4 Potential landslide with saturation of the Toba tuff

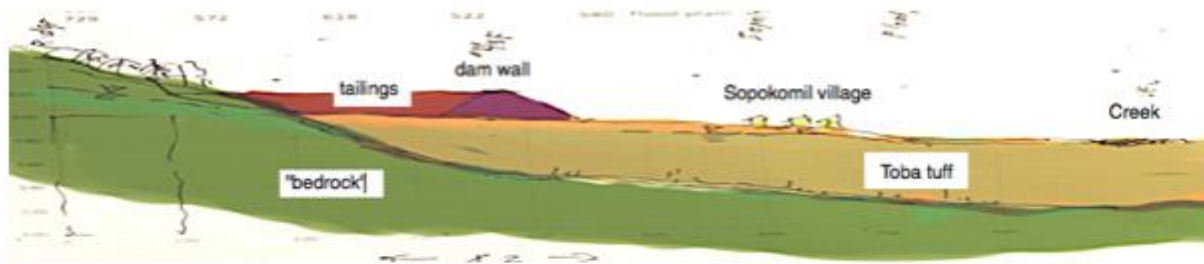
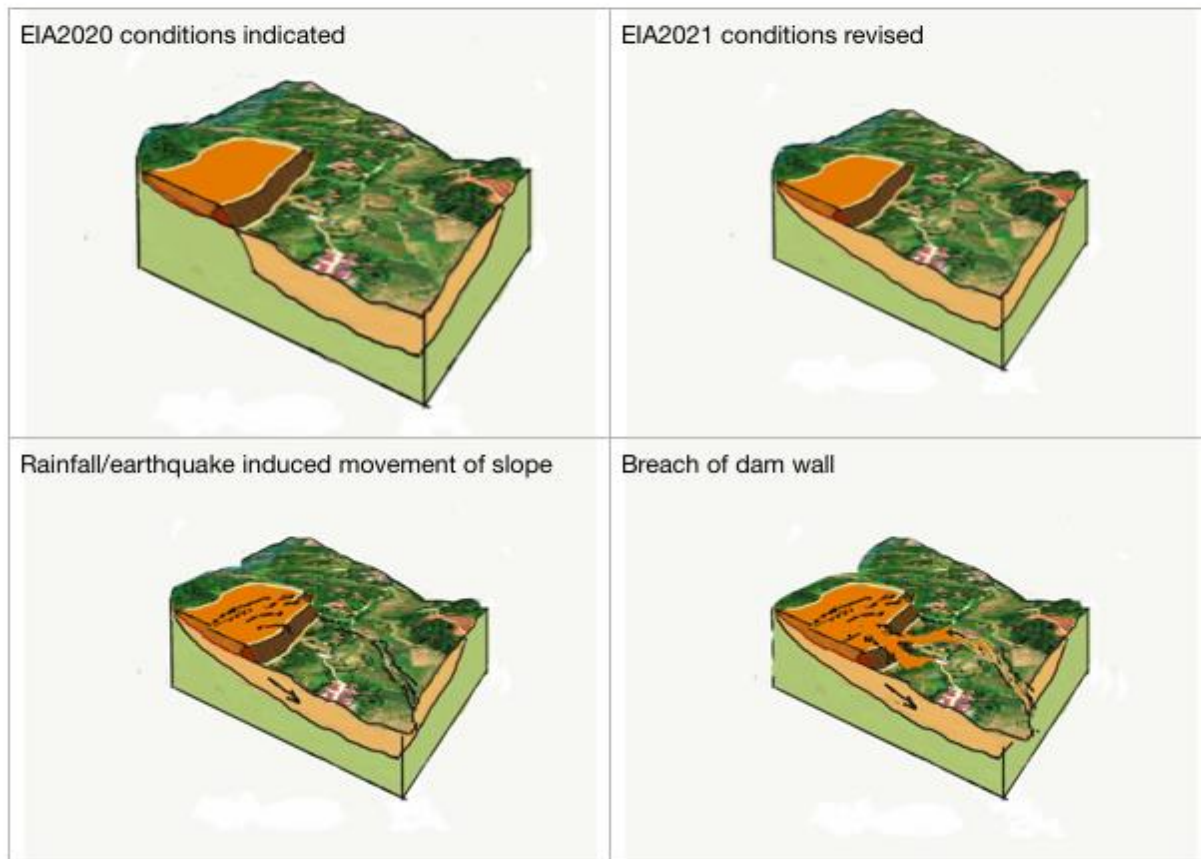
The scenario I have in mind is illustrated on the sequence of images on figure 3 and figure 4. Basically, the whole slope on which the TSF is located could move downslope under the weight of the TSF (indeed, Toba tuff has seen similar landslides (see Appendix A) even without loading associated with a TSF). The lower bound of sliding may be within in the Toba tuff layer or at zones of weakness and high pore pressure at the base of the tuff. With such a movement it is difficult to believe that the proposed TSF would not fail, either collapse or by rupture of linings.

Figure 5 Cross section as verified EIA2021 with likely ground failure scenario brought on by rain and earthquake

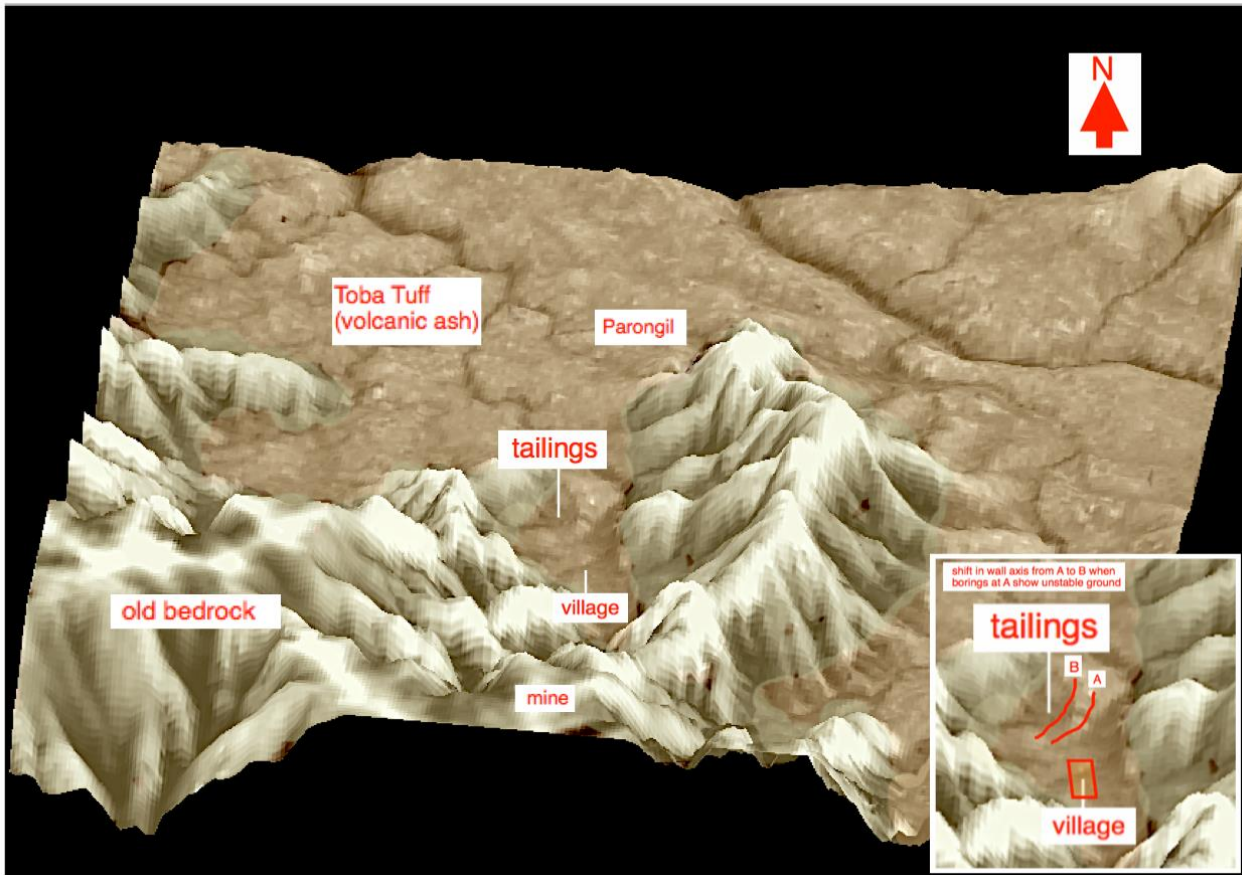
Figure 7 Terrain texture map of DPM TSF site. Lower areas are Toba tuff with protruding bedrock forming the hills around Sopokomil Creek

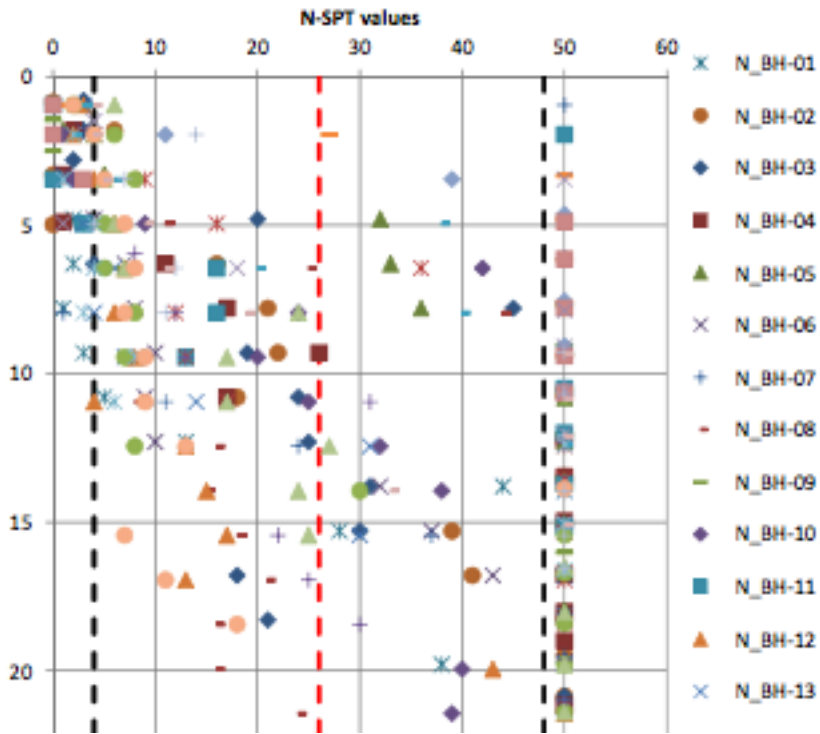
A proposed geothermal plant, the Sarulla project also in the Toba tuff involved recent site explorations which are documented as showing unwelded Toba tuff as being in a loose condition (Standard penetration test N values less than 10) with potential earthquake liquefaction potential in the upper 10-30 meters.

Figure 10 Standard penetration tests in Toba tuff at Sarulla geothermal plant.

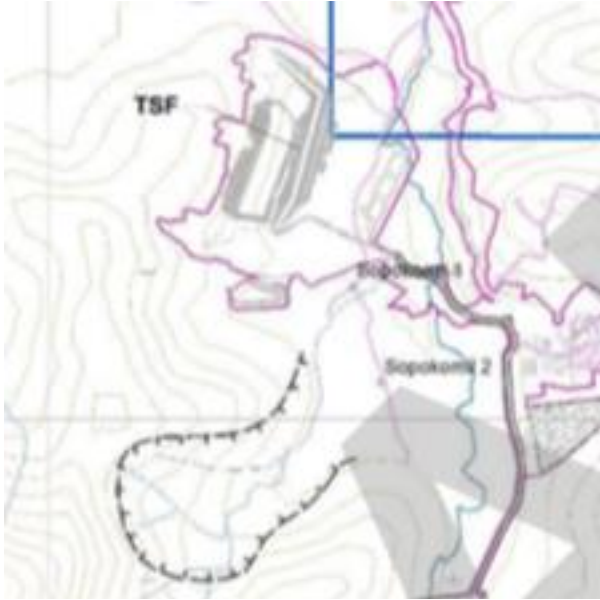
*Figure 13 EIA2021 shows landslide potential adjoining TSF*

The landslides are attributed to the presence of the Toba tuff and although the EIA does not show landsliding at the TSF site itself there is reason to believe that the area is also unstable even without the presence of a TSF. The added weight of the TSF whether of short term or long term size, would aggravate the existing instability.
