# CASE STUDY REPORT

Inclusive Development International (IDI) support for communities in Guinea: Compagnie des Bauxites de Guinée (CBG) in the Sangaredi region

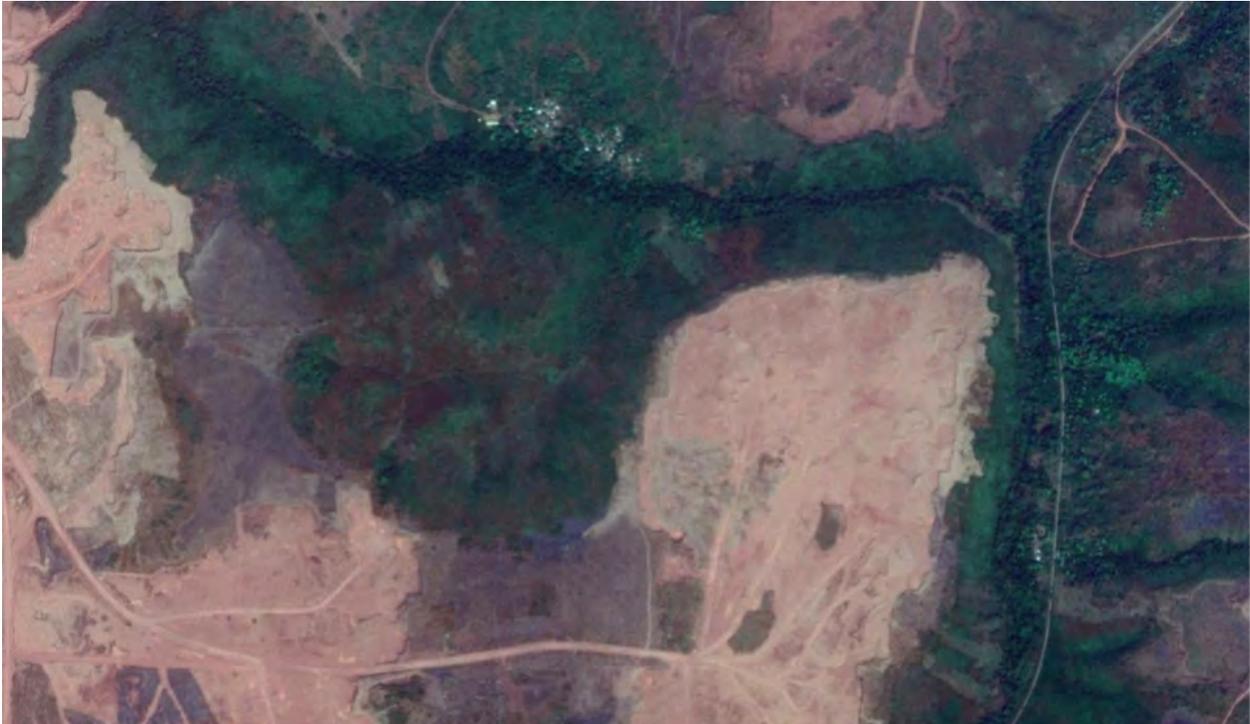
Figure 1. High resolution imagery from December 2016 accessed via Google Earth Pro, showing CBG mining activity close to the village of Boundou Wandé in Boké, Guinea.

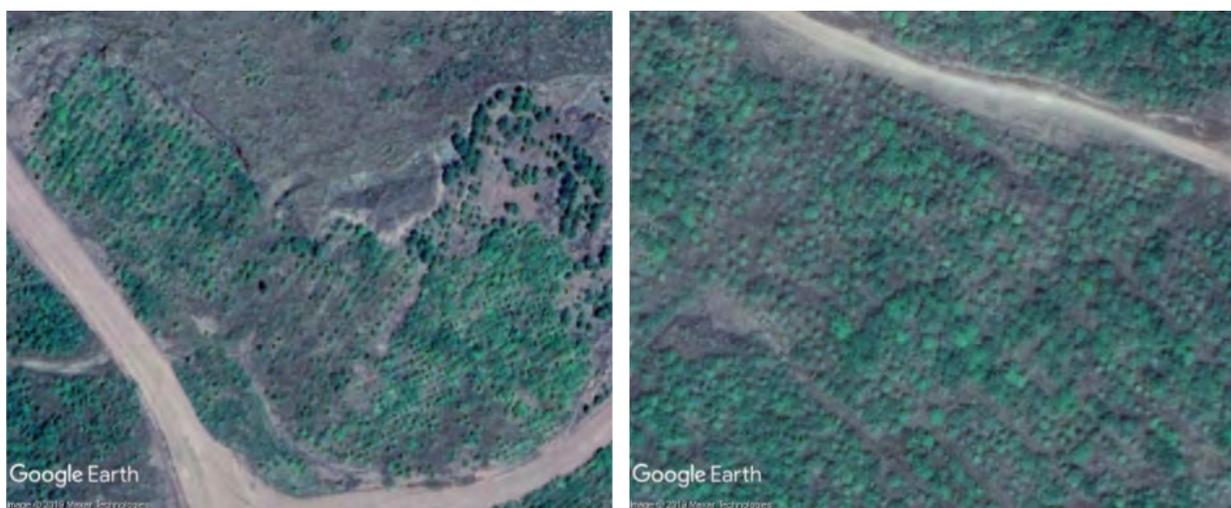
Figure 16. Examples of suspected rehabilitation efforts by CBG in areas previously mined. Mining in these regions is visible between 1973 and 2003 and appears to have ended between 2003 and 2006. Rehabilitation appears to have been performed from around 2006 to 2016.

and some areas could be rehabilitated using methods that cannot be confirmed from satellite imagery alone. Similarly, areas of vegetation that have not thrived due to environmental conditions and/or plant species may mask rehabilitation efforts. Rehabilitation is clear from satellite imagery when the method used results in a grid pattern in new vegetation. These areas are identified from high resolution imagery in the regions first mined between 1973 and 2003. Examples of these areas visible in high resolution images are shown in Figure 16.

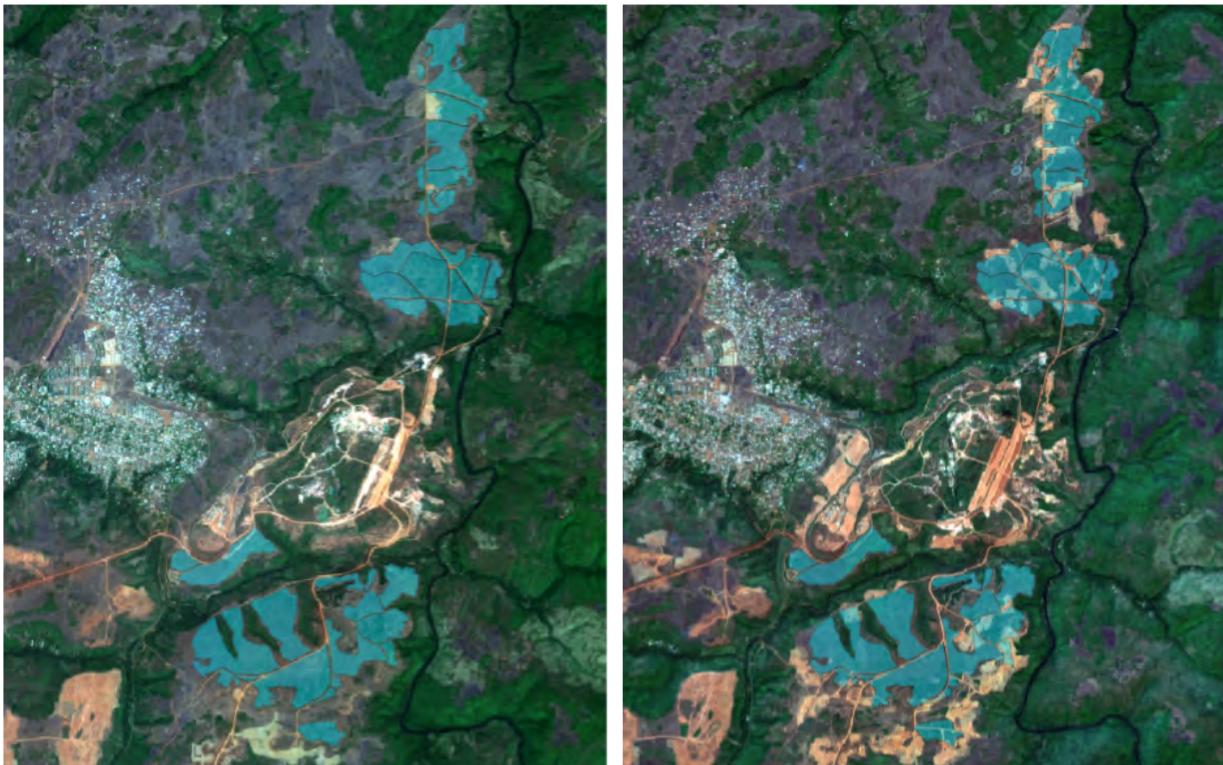
Figure 17. The approximate areas of bauxite mines that appear to have been rehabilitated some time between 2003 and 2016 are shown in blue overlaid onto Sentinel 2 images taken on 13-12-2016 (left) and 03-13-2019 (right).

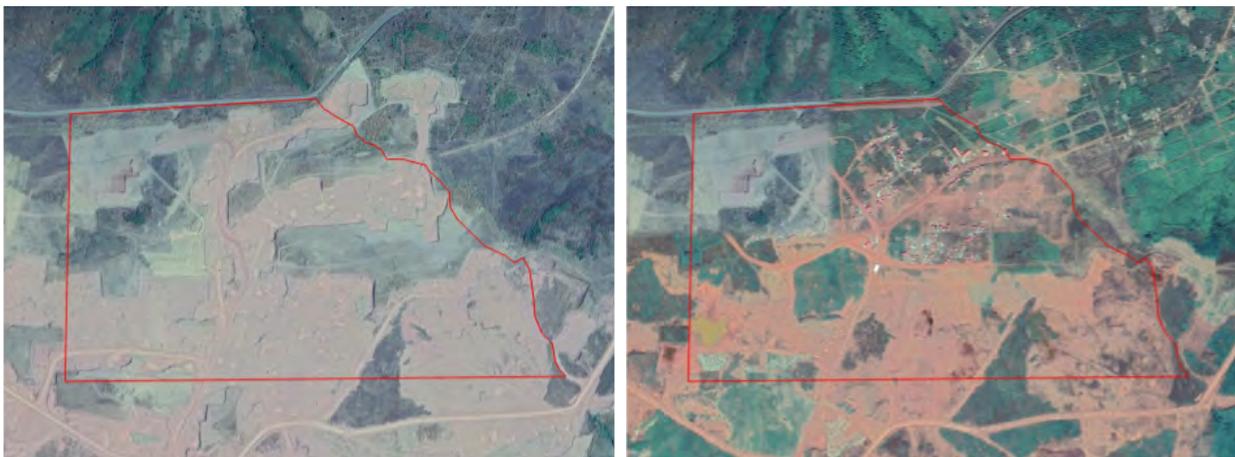
Figure 20. The approximate area marked in CBG materials as New Hamdallaye, the resettlement site for the communities of Hamdallaye and Fassaly Foutabhè, shown in red on Google Earth Pro images dated 24-01-2016 (left) and 30-10-2019 (right).
