**RICHARD L. MEEHAN**

Re: Dairi Prima Minerals (DPM) Mine site risks and Tailings disposal safety. Review of Dairi April 2021 EIA Addendum.

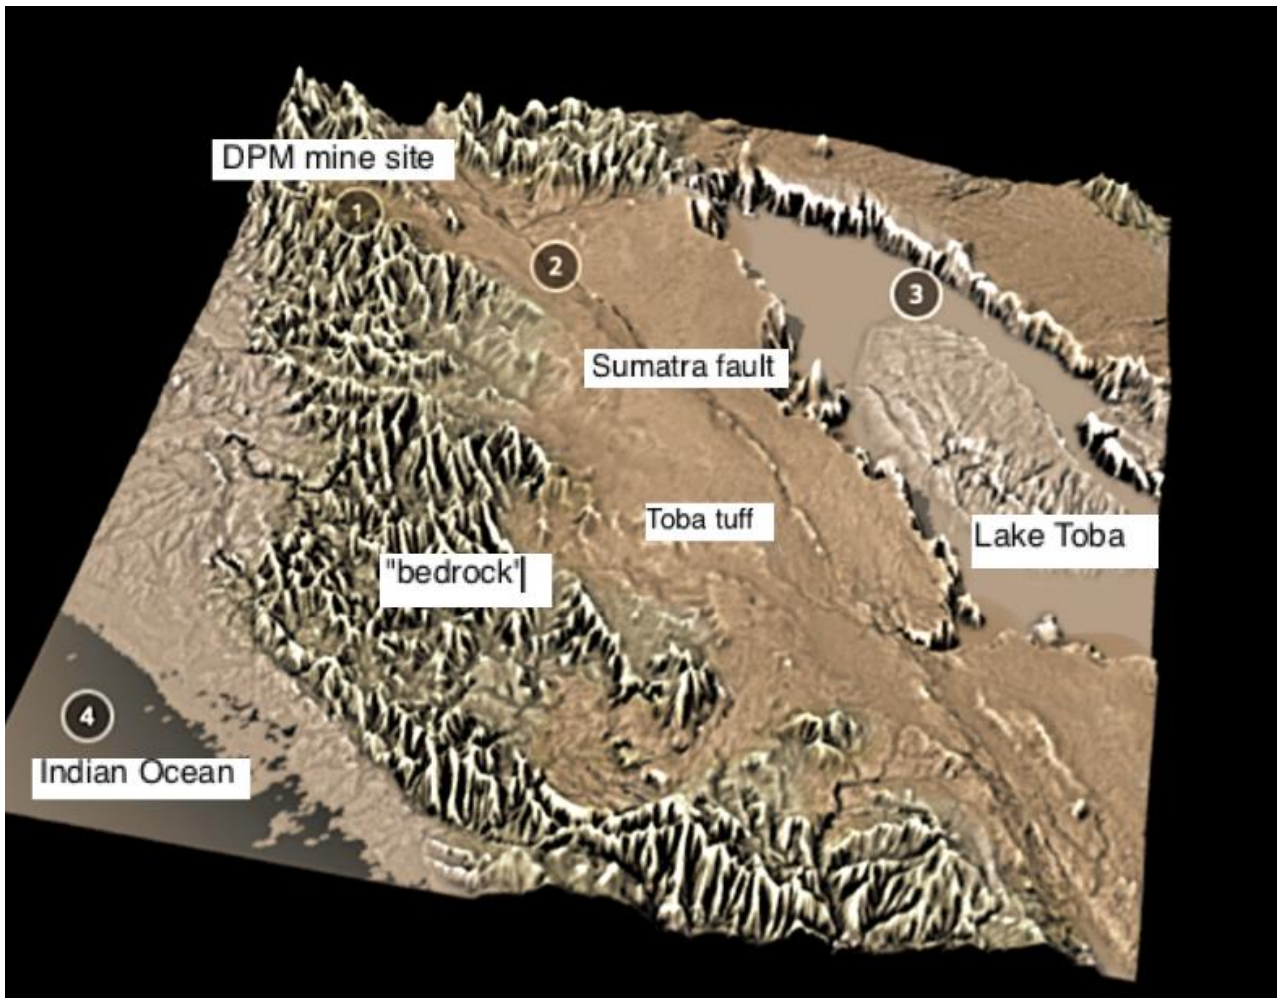
The Toba tuff is an extensive blanket of volcanic ash that covers much of central Sumatra and at least in its youngest phase originated during a great explosive volcanic event centering on Lake Toba 75,000 years ago some 100 km east of the DPM side. The geological character of the Toba tuff is described in Aldiss 1980 and Chester 2011. In the early phase of the DPM project the extent of the Toba tuff mapped by Aldiss was accepted by Middleton 2003 and this general map has subsequently been accepted in the DPM EIA2019 and EIA2021 and verified in the author's study. However, the depth of the Toba tuff at the TSF side and its character has been a subject of some difference in opinion with DPM insisting an absence of significant depth tuff beneath the TSF until the latest EIA2021 which indicates conditions (50+ m depth at the TSF) close to my estimates. In addition to the existing geological mapping the author has carried out terrain processing studies that highlight the extent of the tuff deposits in this part of Sumatra. Two examples are shown in figures 6 and 7 and can be viewed also online in 3-D Per Meehan 2020 C.

*Figure 6 Toba tuff blankets much of central Sumatra*

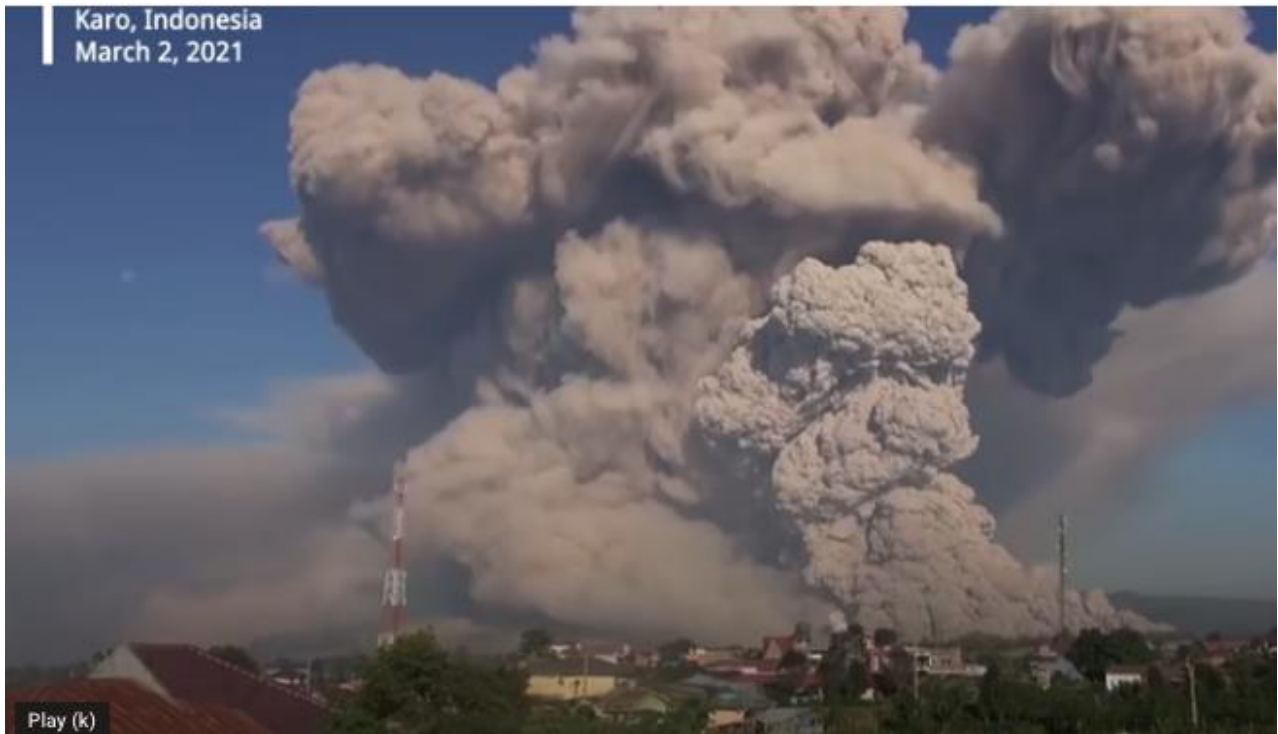
*Figure 8 Mount Sinabung, currently actively spreading volcanic ash 50 km from The DPM site*

The grey, sandy, slushy character of Toba tuff is well known in Indonesia because there continue to be small volcanic eruptions including the region around Dairi. Mount Sinabung which is active in 2021 creates periodic local ash falls usually a few centimeters thick as shown in figure 8 and 9, and various YouTube clips. The very Sinabung volcano has been sporadically active for some time but recent deep deposits of tuff are not seen. Much larger and more dangerous ash falls or floods have attracted attention in historical times are well known at Mount Saint Helens volcano in the US and also in 1815 Mount Tambora in Indonesia. However, none of these match the huge scale of the Toba tuff event which sent ash as far as India and is said to have caused years of global cooling.

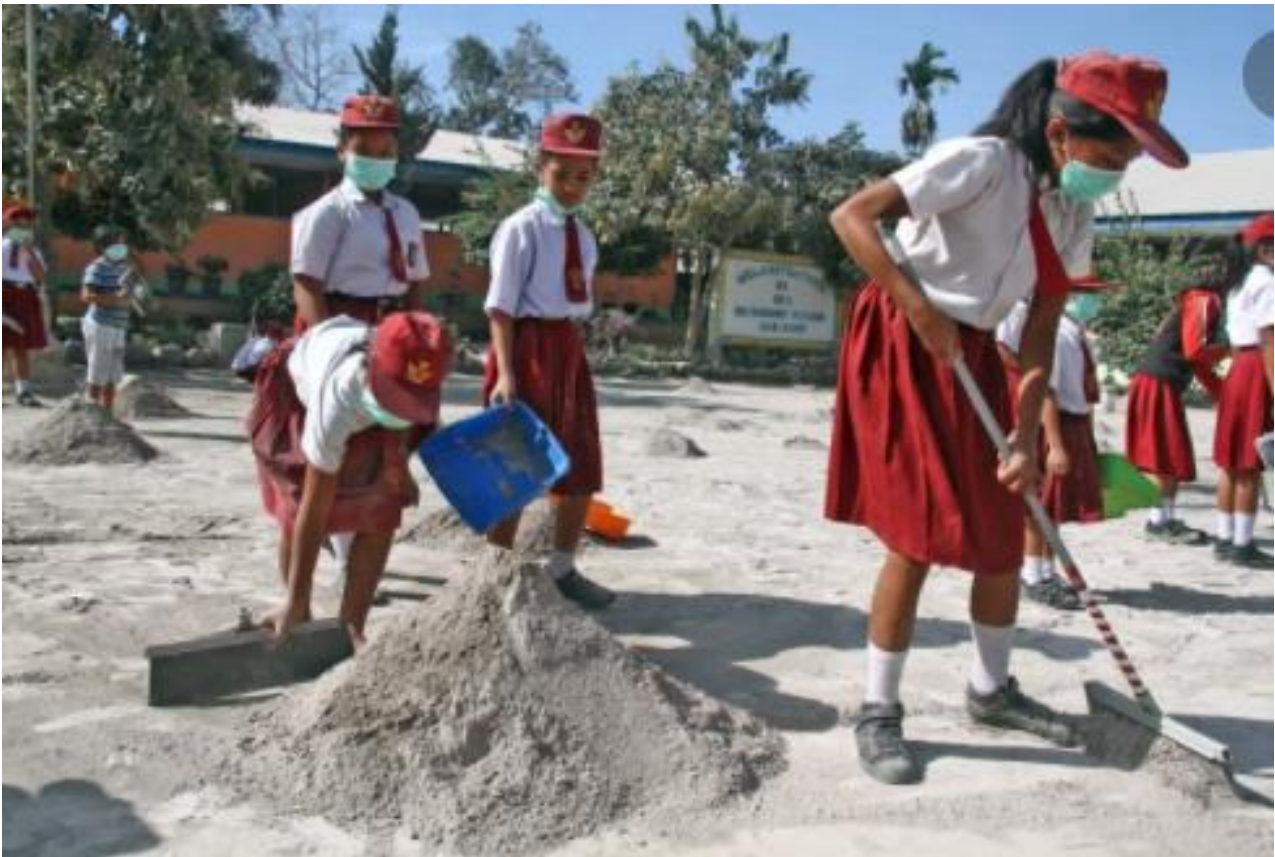
*Figure 9 cleaning of streets after light ash fall from Mount Sinabung volcano*

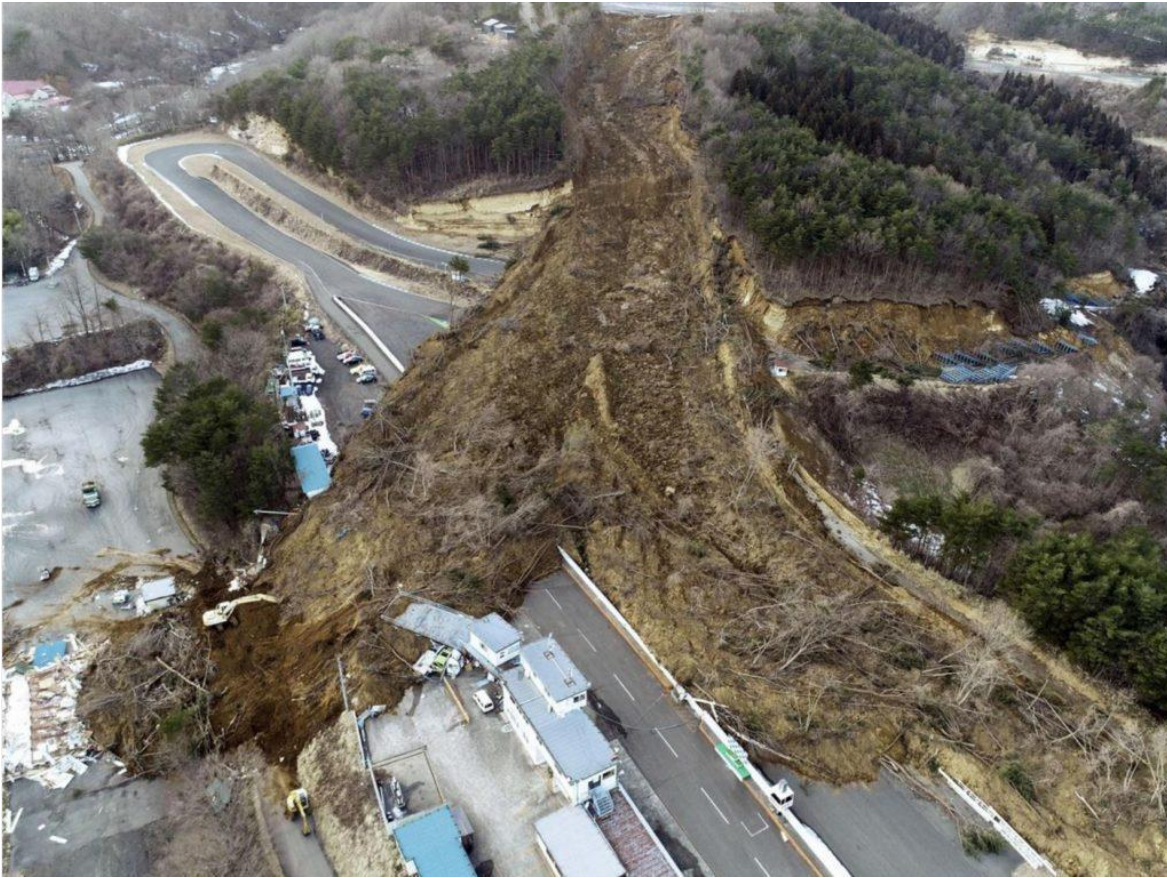
*Figure 11 ash landsliding in Japan 2020, combination rain and earthquake.*

The susceptibility of volcanic ash is well known in many areas of the world where such deposits are present. Japan also features volcanic ash and as recently as June 2020 landsliding occurred in figure 11 with notes by the observing geologist that volcanic soils are particularly dangerous

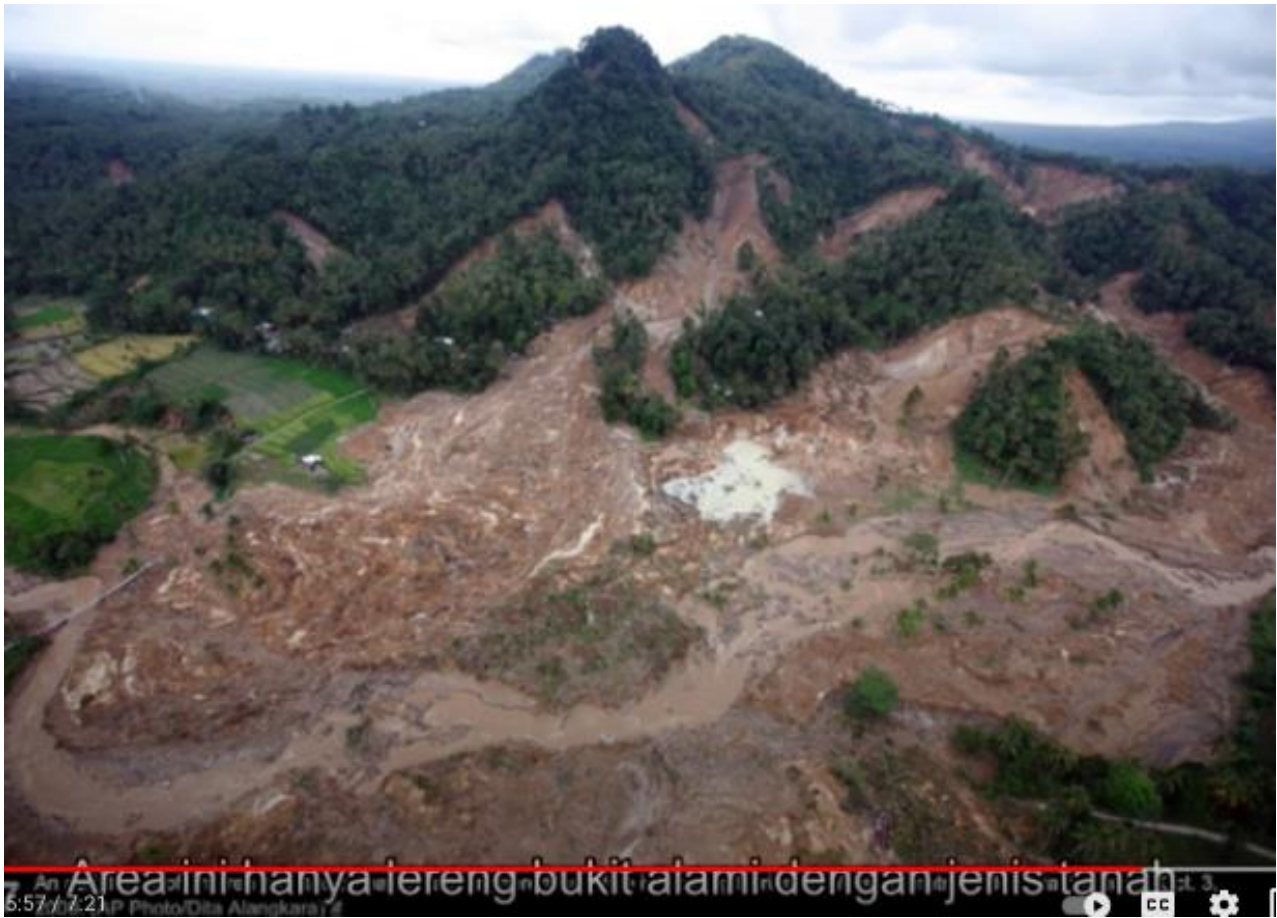
Figure 12: 2009 fatal landslide at Parmina following heavy rain and earthquake
