RICHARD L. MEEHAN

Re: Dairi Prima Minerals (DPM) Mine site risks and Tailings disposal safety.

Summary: Based on information available, and without a site visit, I provide comment on tailings dam stability risks associated with the Dairi Prima Minerals (DPM) mine in Dairi Regency, North Sumatra.

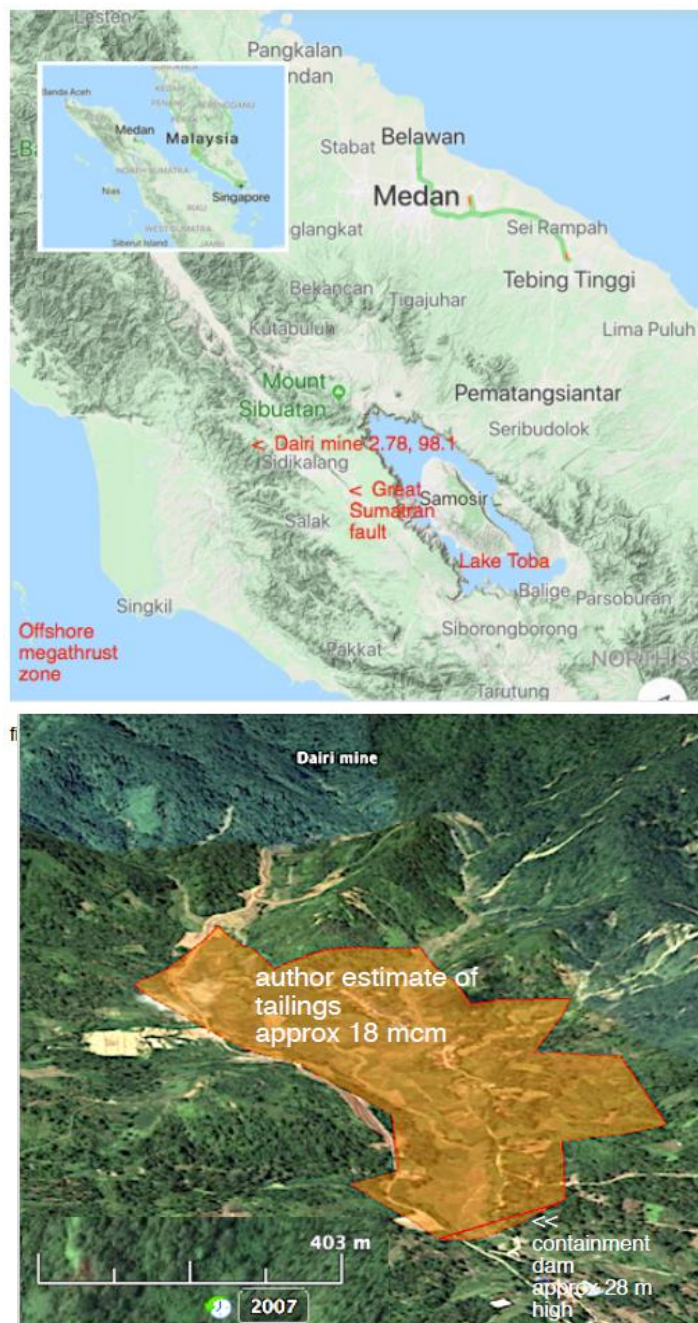
Figure 2. View of author's estimate of tailings

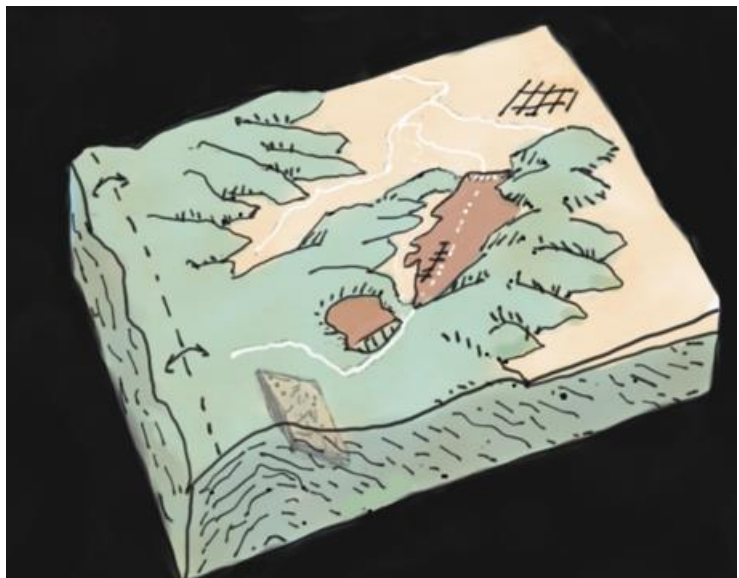
Figure 3a Sketch of general geological features and reported alternate tailings dam disposal areas.

Of special importance are the characteristics of foundation in tailings dam areas. Rocks underlying the entire project area (and containing the various ore bodies) are dominantly very old (Permo-Carboniferous) rocks, carbonaceous shale and dolomitic siltstones, which have been faulted and folding by plate convergence in the Sumatran west coast (Pale green in Figure 3a). According to Middleton 2003 the formation consists of tilted beds with an EW strike and a northerly dip of about 45 degrees with fracturing from brittle tectonic deformation. Inspection of various photos showing recent (2019) road cuts in the Sopokomil valley suggest that the sequence of dipping beds carries down northerly into the hills that flank the valley as shown in my sketch fig 3a.

The eruption of the Toba caldera some 70k years ago flooded the region with hot ash flows (ignimbrite), generally described as the Toba Tuff (pale yellow in Figure 3a). According to Middleton (apparently based on Aldiss et al, 1983) these deposits underlie the Sopokomil valley floor, site of the proposed tailings area. These volcanic

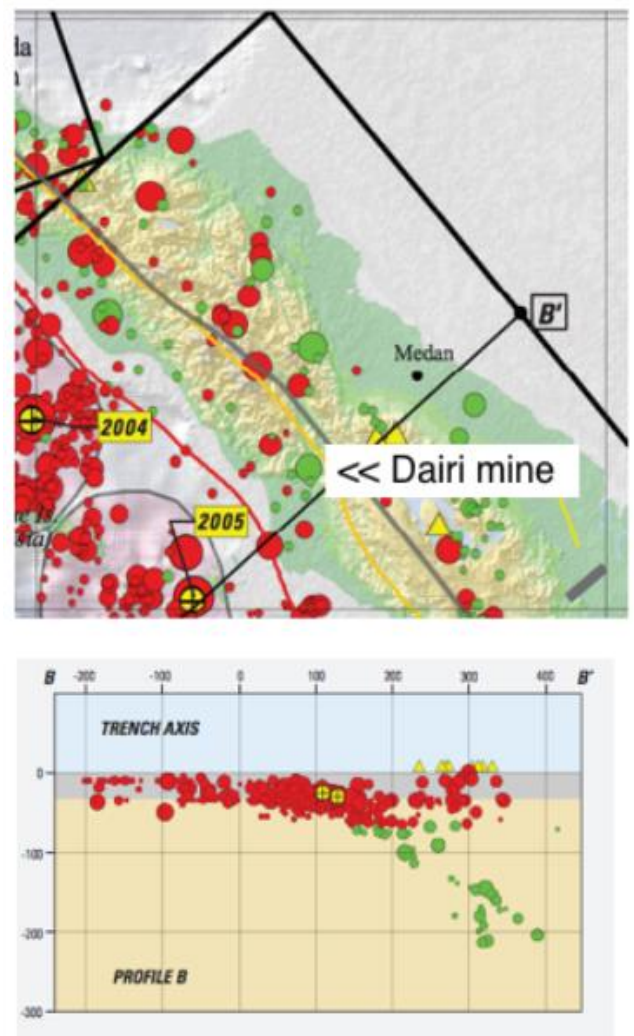
Figure 3. Historical earthquake (Hayes, et al., 2013)

The mine is located in one of the world's most active earthquake regions, along the Sumatra subduction megathrust apparently near a triple plate junction which produced in 2004 and 2005 earthquakes of magnitude 9 and 8+ respectively (fig 3). These events rocked buildings as far away as Bangkok and produced intense regional damage including to road embankments and bridge abutments, which are similar in their behavior to tailings dams. Intensity of ground motion produced destruction of facilities at Banda Aceh, which is a comparable distance from the earthquake to the Dairi mine. Japanese investigators (see Sorenson et al., 2007) found that damage was up to about level 6, Japanese JMA scale. This damage category (6.0-6.4) produces these effects:

A map and cross section showing historical earthquakes is extracted from a comprehensive summary of seismicity of the area published by the US Geological Survey (Hayes, et al., 2013). This map and many other publications provide comprehensive information on regional seismicity sufficient to evaluate earthquake risk.

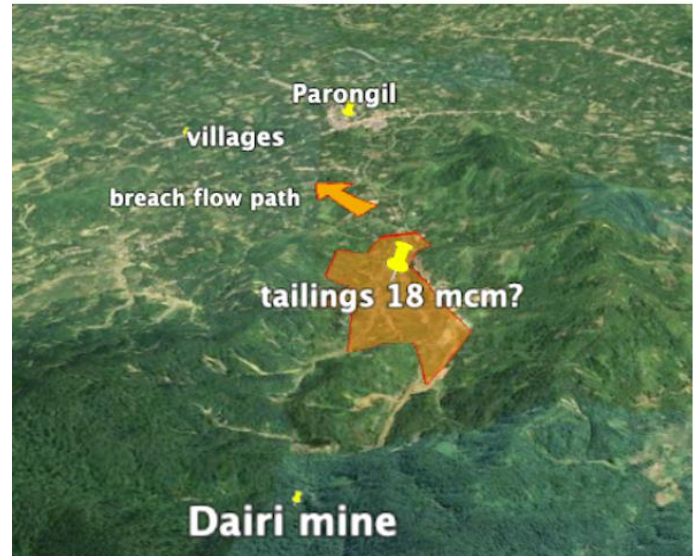
Figure 4. Path of mud wave if a breach occurs.

It has been suggested (Hamilton, oral communication) that the Sopokomil valley and nearby canyon may be the site of an older caldera defined by a circular ridge line which can be seen in figure 4. Such features are often underlain by rhyolite rocks associated with a rising body of extrusive lava. Such rocks are typically fractured and water-bearing.

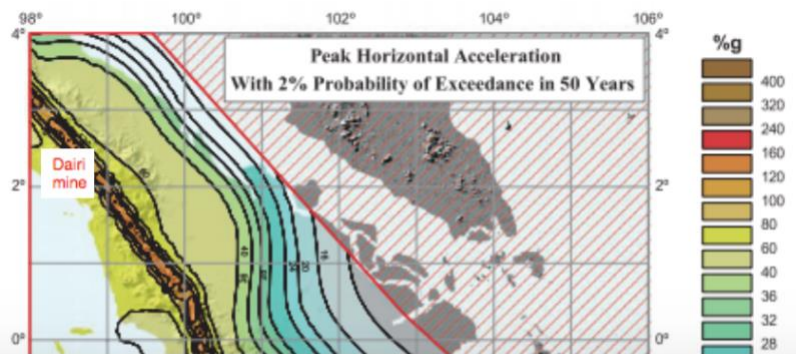
figure 5. Tailings dam very close to Sumatra fault with likely earthquakes up to M 7.5-7.9 and ground accelerations of 100%g

Although the offshore subduction zone mega earthquake poses a threat to long-period structures like tailings deposits, a more dangerous type of earthquake can be expected from the Great Sumatra fault which breaks ground only 15 km to the east of the Dairi site. According to Peterson et al (Ref Petersen et al., 2004) and others this fault is capable of generating earthquakes up to magnitude 7.5 to 7.9 and at this close distance are likely to produce very high ground accelerations on the order of 50-100% gravity (Figure 5).

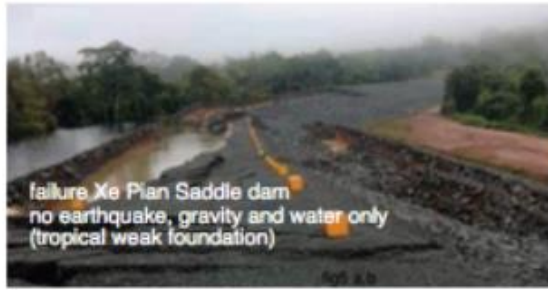
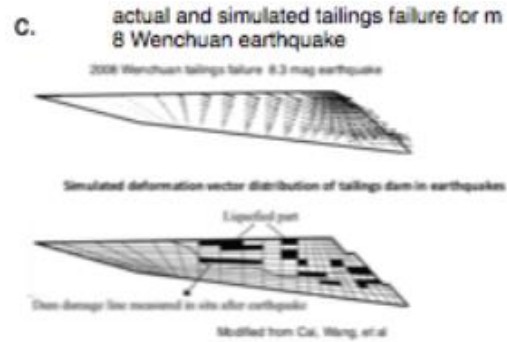
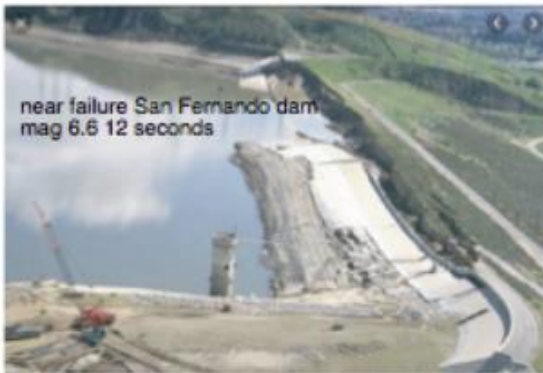
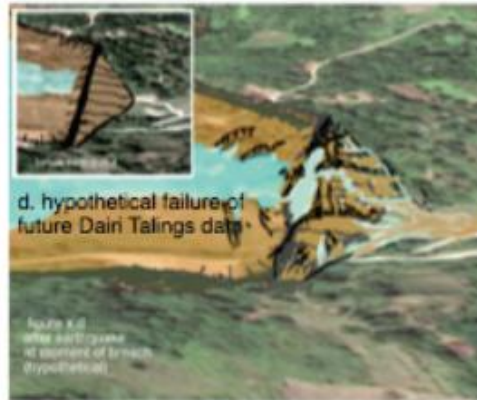
figure 6. a. Failure of Xe Pian dam in Laos 2008; dam breached shortly after this photo with runoff of 500 mcm water flowing 100 km and obliterating 6 villages. No earthquake here, but poorly built dam founded on typical weak leaky tropical soils made dam unable to survive filling of the reservoir b. Near failure of the San Fernando dam in California in a short m 6.6 earthquake. Another few seconds of shaking would have breached this dam with a great death toll. c Analysis by Cai, Wang, et al of a tailings dam in the 2008 Wenchuan earthquake shows that the dam fails in a m=8 earthquake. d. Likely performance of a tailings dam at Dairi mine during a very strong earthquakes, probably from the Great Sumatran fault zone near the site.

As shown in studies of the tailings dam failure at the Wenchuan earthquake in China (Ref Cai et al, figure 6c), embankments, including tailings dams, characteristically concentrate and channel rising earthquake energy toward the crest - so that the destructive intensity may be two or three times greater in the upper part of the tailings compared to at the ground base of the impoundment. It would be extremely difficult and expensive to design a tailings confinement dam that could withstand this level of shaking without cracking and displacement, even assuming the best of all foundation conditions in the valley, an assumption which is not likely to hold true in tropical volcanic terrain.

considering that the earthquakes will come in clusters - main shocks followed by aftershocks (Figure 6d).

Failure of the containment for wet tailings would be most dangerous in the wet season with an abundance of water added to the containment. Cracking and sliding of the retaining structure would initially take on the appearance of the partial failure of the San Fernando dam, figure 6b (Castro et al 2003). But the San Fernando dam was subjected to only a few seconds of strong shaking. Larger earthquake from m 7.5 to 9 would produce shaking that would be much longer in duration with cracks and sliding of many meters in even robustly built dams. This would open the embankment to through flow of water and wet tailings, which would breach the Dairi containment (as in the Baldwin Hills Reservoir shown on video at <https://www.youtube.com/watch?v=c4sm7DdIMkk>) and also the Brazilian Brumadinho Mine.
